TD-05-032
10/05

EDDY CURRENT SCANNING REPORT

FNAL-3RDHARMONIC CAVITIES #3-6

FNAL/Technical Division

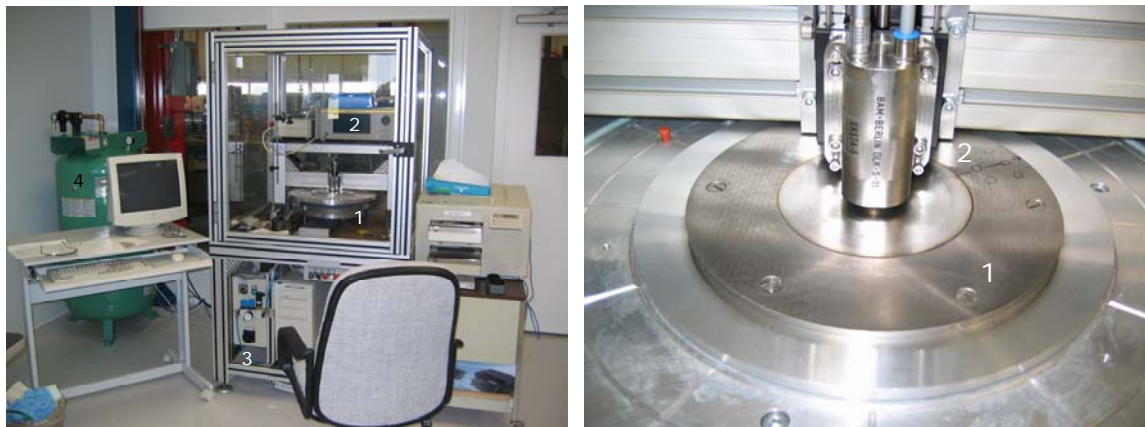
Figure 1: Left: SNS eddy current scanner at Fermilab. 1) turn-table with sample, 2) eddy-current tester, 3) main panel, 4) compressed air receiver. Right: sample-holder with sample and eddy-current probe.

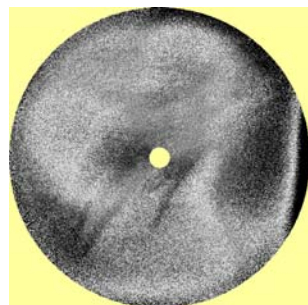
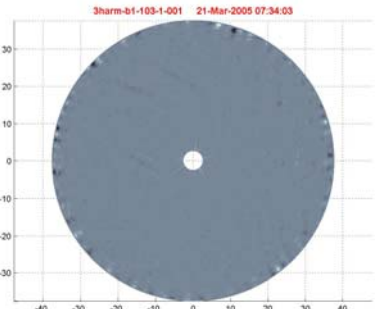
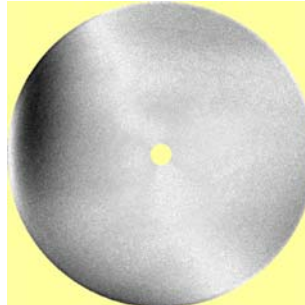
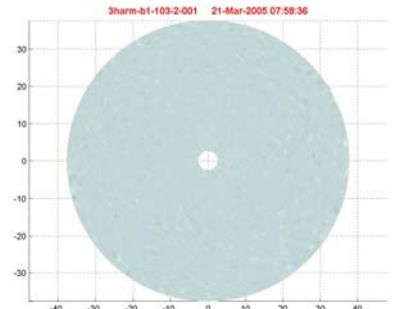
Disc 102 – side 1/2;

102	S1: Light surface scratches S2: Light surface scratches, pit center	S1: OK S2: NO
103	S1: Ding center, roller marks and defect from Filter S2: OK	S1: NO S2: OK
104	S1: Tiny pits throughout, scratch at 45 deg OR S2: Light surface scratches	S1: NO S2: OK
105	S1: Light surface scratches, roller marks from filter S2: Light surface scratches	S1: NO S2: OK
106	S1: Light surface scratches, roller marks from filter S2: Light surface scratches, roller marks from filter, irregular thickness	S1: NO S2: NO
107	S1: Light surface scratches, defect from filter S2: Various pits throughout, roller marks from filter	S1: NO S2: NO
108	S1: Tiny pits throughout, light surface scratches S2: Pit at 45 deg MR, light surface scratches IRREGULAR THICKNESS	S1: NO S2: NO
109	S1: Light surface scratches S2: Light surface scratches, tiny pits throughout	S1: OK S2: NO
110	S1: Tiny pits throughout S2: Various pits throughout, light surface scratches	S1: NO S2: NO

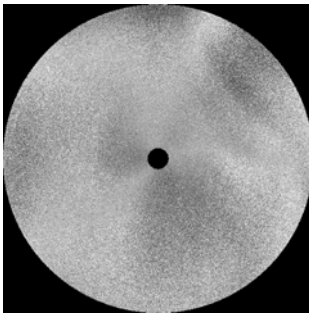
Disc 130 – side 1/2;

130	S1: Light surface scratches, tiny pits throughout, ding at 280 deg MR, defect from filter S2: Light surface scratches, tiny pits throughout, ding at 140 deg MR and OR	S1: NO S2: NO
131	S1: Light surface scratches, DIRTY S2: Light surface scratches	S1: OK S2: OK
132	S1: Light surface scratches, a little deeper than normal, ding at 100 deg MR, roller marks and defect from filter S2: Light surface scratches, ding at 5 deg MR close to center	S1: NO S2: NO

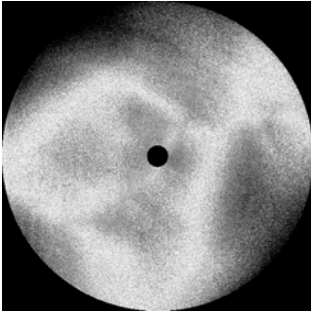
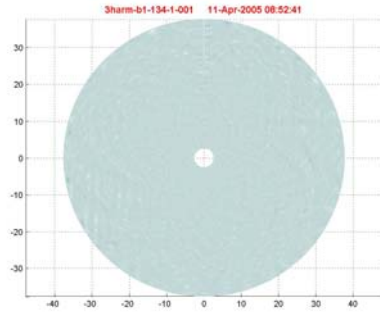
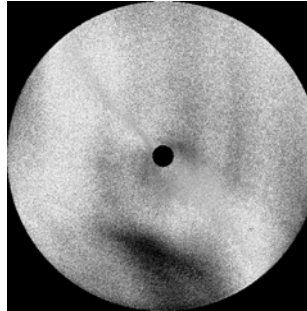
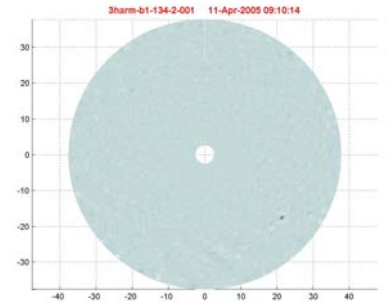
Disc 133 – side 1/2;

133	S1: Dirty, scratch at 320 deg MR S2: Dirty	S1: NO S2: OK
134	S1: Light surface scratches S2: Pits MR between 90-180 deg, defect at 110 deg as seen from filter	S1: OK S2: NO
135	S1: Pits throughout, 9 defects, mostly lower half, one at 40 deg as seen from filter S2: Tiny pits throughout	S1: NO S2: NO
136	S1: Tiny pits throughout, light surface scratches, ding at 110 deg MR S2: Tiny pits throughout	S1: NO S2: OK
137	S1: Light surface scratches S2: Light surface scratches, dirty, ding at 355 deg MR	S1: OK S2: NO
138	S1: Dirty, light surface scratches S2: Dirty	S1: OK S2: OK
139	S1: Dirty, light surface scratches S2: Dirty, light surface scratches	S1: OK S2: OK
140	S1: Dirty S2: Dirty, light surface scratches, black spot at 0 deg MR scratch at 10 deg MR	S1: OK S2: NO
141	S1: Very tiny pits S2: Light surface scratches	S1: OK S2: OK
142	S1: Faint roller marks at 180 deg as seen from filter S2: None	S1: NO S2: OK

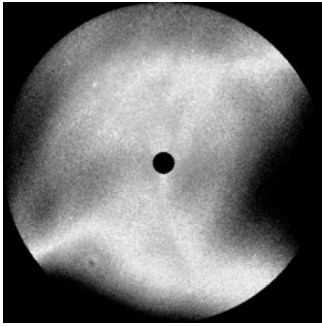
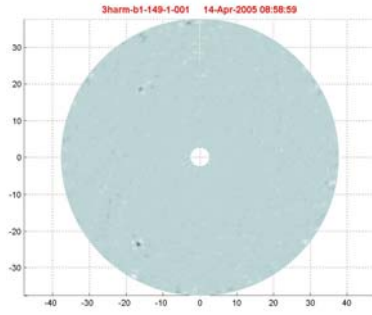
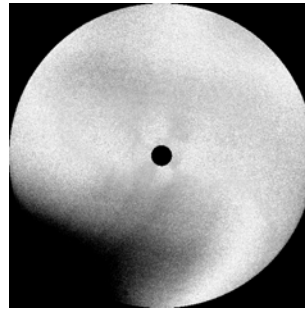
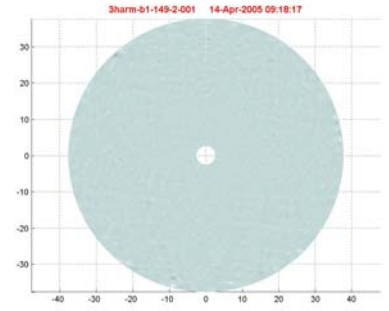
Disc 148– side 1/2;

Profilometric measurements were performed on discs 134, 135, 144, 148, 149 and 150 to estimate the depth of the etching pits. These pits vary from 0.2 to 0.5 mm in width and from 10-90 microns in depth. Appendix 1 lists the sum of the data. These profiles would indicate that subsequent etching of ~120 microns would remove them, such as was found in one case in the previous study (in the other case such an etch was not sufficient). The so called “roller-marks” did not give any measurable profile (our equipment for profilometric measurement might not be capable of detecting long range effects, however).

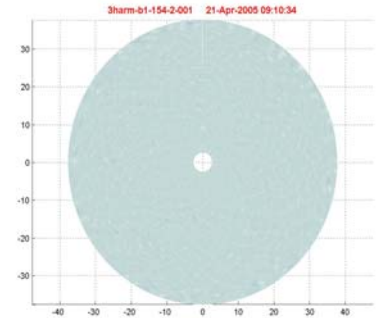
Disc 153– side 1/2;

153	S1: Slight nick at 355 deg MR S2: Light surface scratches	S1: OK S2: OK
154	S1: Light surface scratches, tiny pits throughout S2: Light surface scratches, tiny pits throughout	S1: OK S2: OK
155	S1: Light surface scratches S2: Light surface scratches	S1: OK S2: OK
156	S1: Dirty, ding at 180 MR S2: Dirty, strong roller marks as seen from filter	S1: NO S2: NO
157	S1: OK S2: OK	S1: OK S2: OK
158	S1: faint defect at 210 deg as seen from filter S2: Ding at 290 deg MR-OR	S1: NO S2: NO
159	S1: OK S2: Tiny pits throughout	S1: OK S2: OK
160	S1: Tiny pits throughout S2: OK	S1: NO S2: NO
161	S1: DIRTY S2: Tiny pits throughout, faint roller marks at 200 deg as seen from filter	S1: OK S2: NO
162	S1: Tiny pits throughout S2: Light surface scratches	S1: OK S2: OK
